# Abrams Tank Systems

**Lessons Learned**  
**Operation Iraqi Freedom**  
**2003**

# Purpose

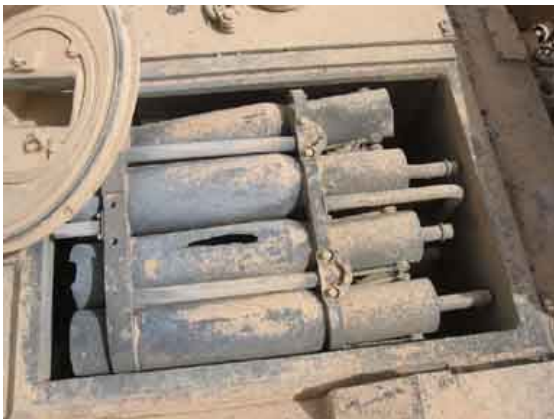
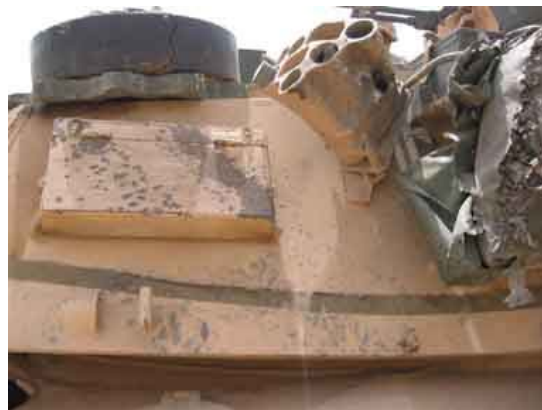
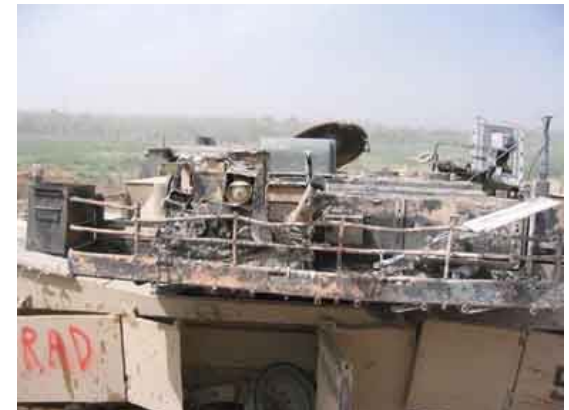
- I Turret ammunition blast doors worked as designed**
  - ❖ Documented instance where turret ready rack compartment hit and main gun rounds ignited. Blast doors contained the explosion and crew survived unharmed except for fume inhalation
- I Externally stored items highly vulnerable to small arms fire**
  - ❖ In some instances, catastrophic losses resulted from burning EAPU material and/or packaged POL products dripping down into the engine compartment catching the engine on fire
  - ❖ Many instances where TA-50 lost or damaged due to enemy fire or secondary affect
  - ❖ Lesson Learned – Review and adhere to established load plans

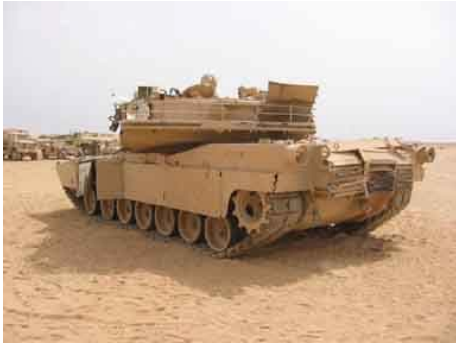
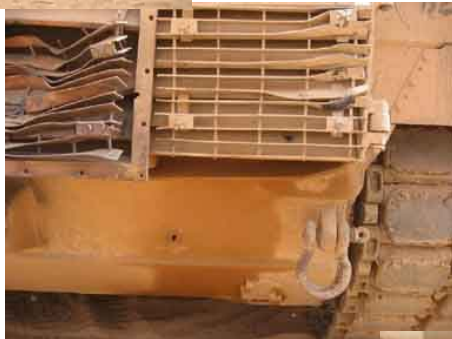
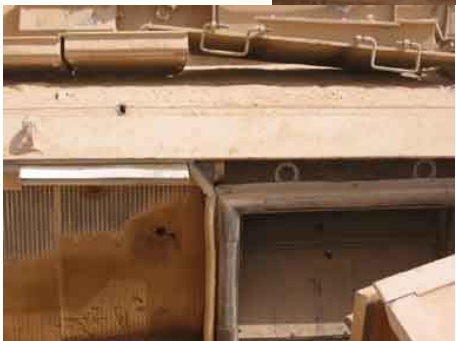
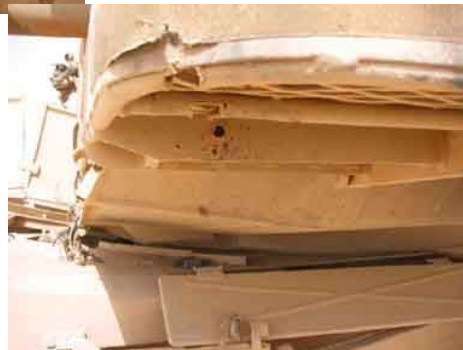
# 26 March, An Najif - B24, 3-7 Div Cav

## Vehicle disabled from 25mm penetration of engine compartment

Pitting from multiple small arms

RPG

Glanced off top of turret

1-1 1/2" penetration

25mm

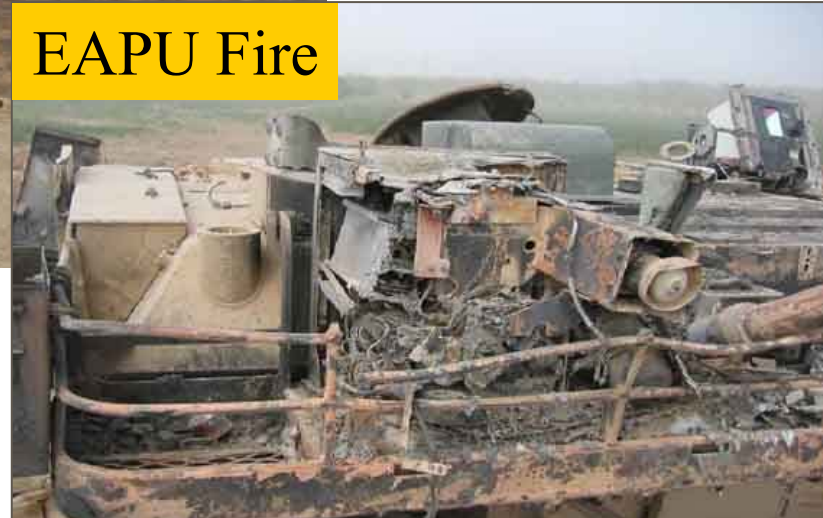
EAPU Fire

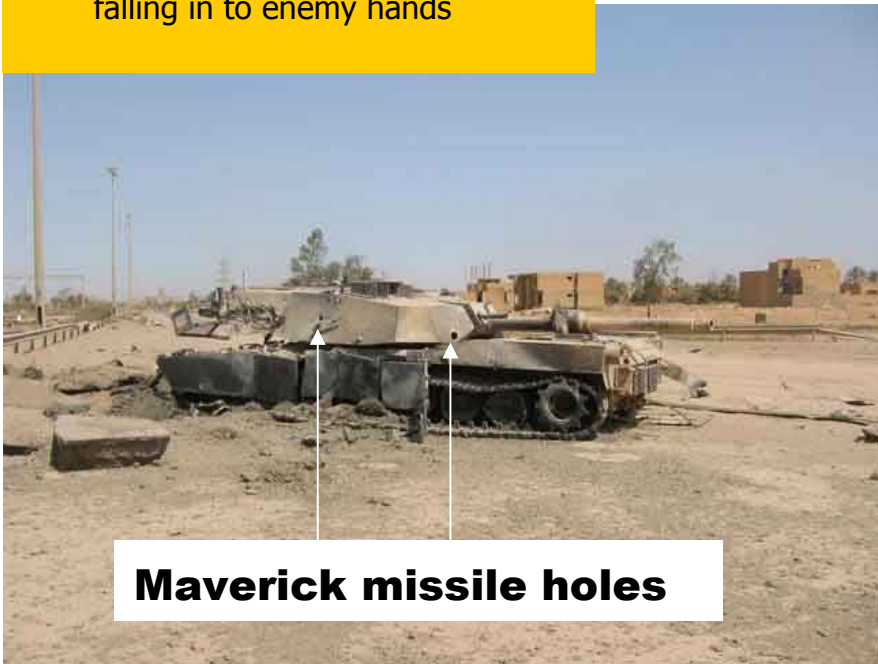
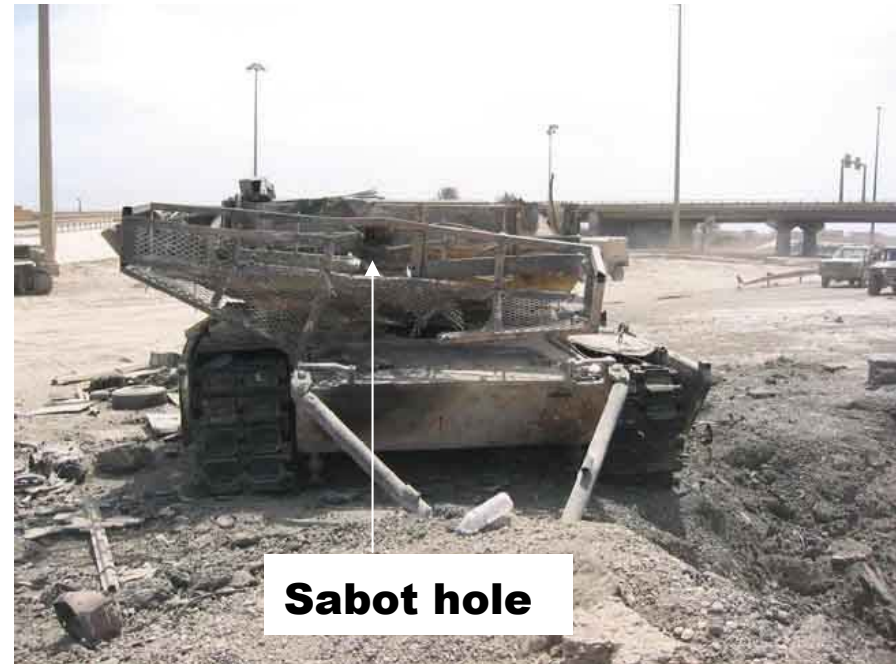
1-64 AR, C12

Being towed back to UMCP  
because of engine fire. Purposely  
destroyed by unit to keep from  
falling in to enemy hands

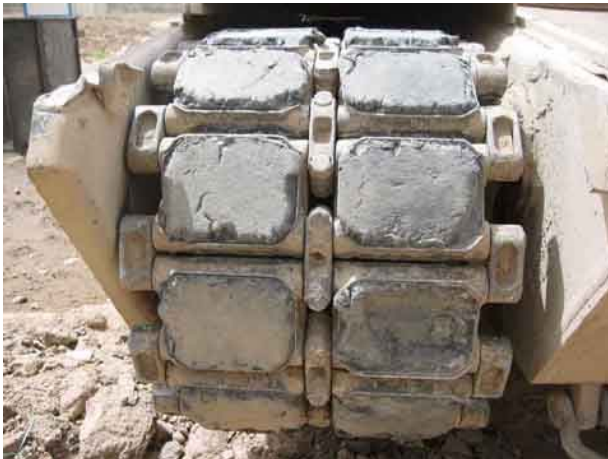
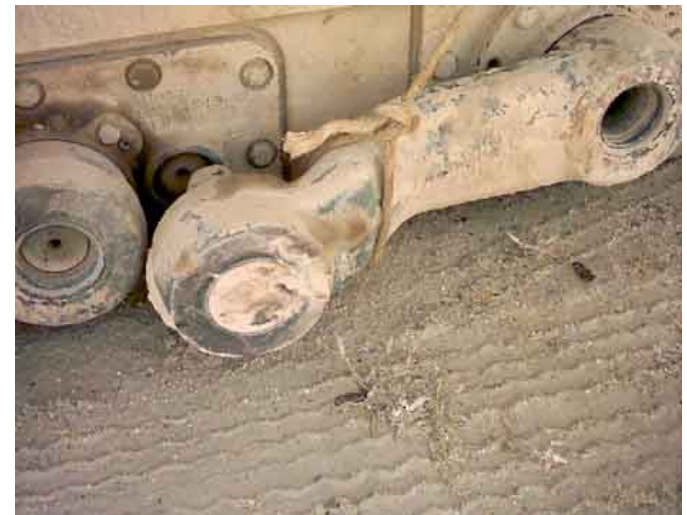
- | **APS fleet is not equipped with PJAS. Given the extreme dusty conditions, VPACs required continuous cleaning and servicing by crews. Suspect lack of PJAS contributed to higher rate of engine failure**
- | **Suspension Issues**
  - ❖ **High rate of failure on #2, #3 and #5 left and right road arms and assemblies**
    - **Under investigation by PM Abrams and GDLS engineers**
  - ❖ **Road wheels and track wear proved to be significant over long distances and high rates of speed**
